June 05, 2021

3271

Terrain Stability Assessment: K1H-CP3-65, Martinson Creek, Bell Mountain - McBride Area

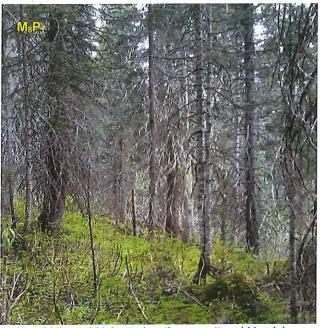
In the Martinson Creek draw (external to the block), thickened granular soils occur as Holocene draped fluvial deposits of Martinson Creek. At the draw crests, some winnowing of the sand fraction likely occurred at the peak of the glacial melt, It has left an elevated boulder fraction now locally constrained the draw crest regimes. Thickening fluvial deposits within the draw and the noted boulder remnant at the crest are shown in Photo M_1P_2 at GPS location M_1 .

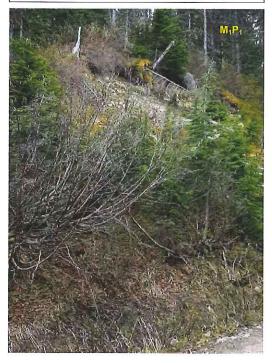
The local site condition is uniformly planar slopes with variably gentle through moderate repose (12° - 24°±). Moderately steep slopes (28° - 35°), do occur in the Martinson draw, but are similarly uniformly planar within drained granular deposits. Locally also, the groundwater plainly recedes to significant depths on these steeper slopes. Highest exposed slopes were along the existing road where it crosses this stream. Cuts were 5m or 6m at 33° - 38° and without any indicators of past or ongoing activity, nor any condition portent of future destabilization.

Also, for drained conditions as are extant locally, the stability is independent of the thickness of the soils. For instability (Factor of Safety = 1.0), a proportionate height of groundwater h, of $0.38 \le h \le 0.4$ is required. From the discussion above for constant flow Q, the expected mean maximum height of groundwater in the steepening slopes would be only $^{5}/_{16}$ m or a 0.052 proportionate height within the 6m thickness of soil. Hence stability is very good, as demonstrated by the six metre cuts at 38°, now some decades in age, and showing arguably zero degradation (See Photo M₁P₁ at location M₁, left).
